FINAL - PLAN OF DEVELOPMENT BLUFF EROSION & ENHANCEMENT PROJECT

Tetra Tech, Inc. September 2000

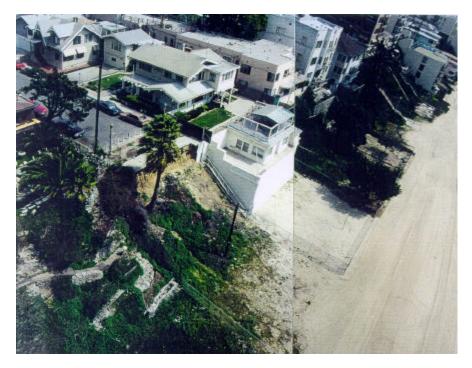
Current condition of 1st Place

- Bluff Failure
- Public Property Endangerment

The bluff area falls within the 1st Priority category. The calculated factor of safety is near 1.0 on static conditions. The slope is potentially unstable. Severe erosion is undermining the sidewalk at the end of the street.

Proposed Improvements: A reinforced slope will be engineered to stabilize the bluff while maintaining a vegetated bluff appearance. The repair of this bluff will be coordinated with the new condominium development on the east side of 1st Place. This new development will generate fill to be used for the engineered slope. The top ten feet of reinforced slope will be almost vertical with the remaining slope being 2:1 to match the existing grade on the property to the west of 1st Place. In addition, coordination with the owner of this landmark Greene & Greene designed home will be necessary for constructing the reinforced slope and consequent grading. The existing palm tree and utilities will be relocated as a result of this work.

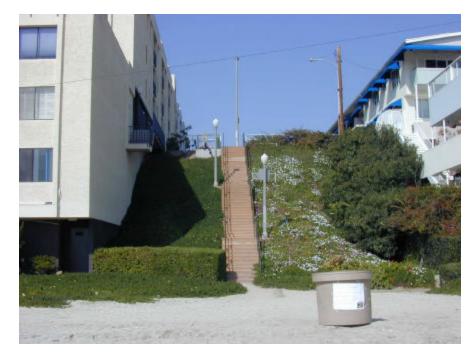
Current condition of 5th Place

Jacuzzi or spa drainage pipe from the building to the west has caused some localized erosion on the slope, not visually evident.

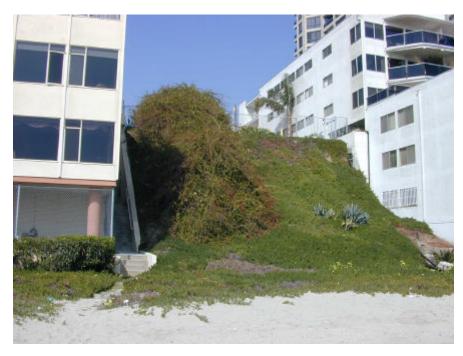
Current condition of 7th Place

- Bluff Failure
- Appearance
- Drainage From Private Property

The bluff area falls within the 1st Priority category. The calculated factor of safety is near 1.0 on static conditions on the east side, which represents a potentially unstable slope. This is confirmed by a small failure which has occurred on the top of the slope on the east side which has undermining the sidewalk.

A concrete retaining wall with a sloping top retains most of the western edge of the slope. However, localized drainage which is causing erosion is evident along the wall. Based on information provided by a local resident, it is understood that the slope was regraded to its existing condition and re-planted after a shallow landslide. Shallow, terraced modular block walls have been placed by the residents along the lower eastern parts of the slope.

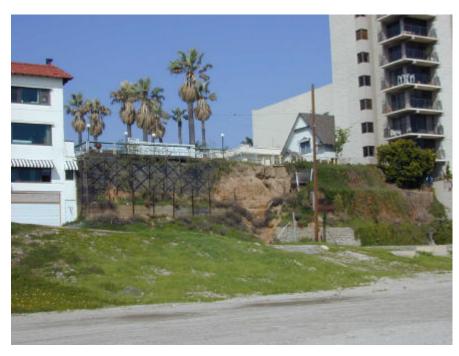
Current condition of 12th Place

- Bluff Failure
- Public Property Endangerment
- Private Retaining Wall
- Appearance
- Access
- Utilities

Existing Issues: The City property at the end of 12th Place constitutes approximately 55 feet of the bluff and is bordered by private property on each side. The overall slope height is about 30 feet. The slope is retained by two timber walls covered by vegetation that have an overall (top to bottom) inclination of 1:1. The bluff is very steep, showing evidence of surficial failures/slumps, and it has been shored by a variety of means. A masonry retaining wall is visible along the toe of the slope. The wall appears to wrap around the eastern edge of the public right-of-way (Bluff Place) and supports grade differentials of 5 to 8 feet. Bluff Place is located along the toe of bluff and provides emergency vehicle access to the beach. There is a private retaining wall to the west that is showing evidence of failure which should be assessed as soon as possible. The two walls do not contain the entire bluff leaving the center section (area between private and public property) exposed and consequently failing.

The bluff area falls within the 1st Priority category. The calculated factor of safety within the unsupported section is near 1.0 on static conditions, which represents a potentially unstable slope.

Proposed Improvements: Due to the apparent undermining of the existing retaining walls and the adjacent private retaining wall failure, an engineered retaining structure is called for. The proposed retaining structure must be coordinated with the private property owners on the east and west. Due to the proximity of the adjacent structures, public improvements and the spatial limitations at the toe of the bluff, a near vertical retaining structure may be required. The structure will be designed to incorporate a vegetative cover to respond to the community interests. These bluff improvements will result in the realignment/regrading of existing Bluff Place, which will provide emergency vehicle and handicap access to the beach. The sloped area will be re-landscaped with palm trees, low-profile seashore plants and look-out seating areas. Utilities will be relocated and additional lighting will be provided for security.

- Replace Retaining Structure
- Coordinate with Private Property Owners
- Relandscaping and Lighting
- Utility Relocation
- Handicap Access
- Seating Areas

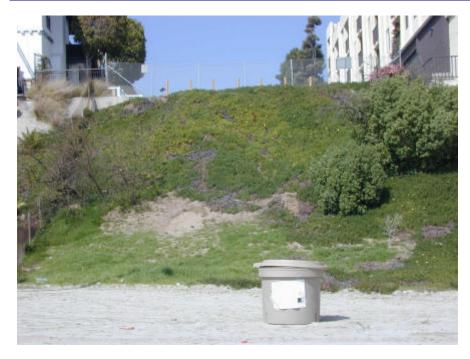
Current condition at 4th Place

- Drainage
- Surficial Failure
- Bluff Instability
- Adjacent Private Property Slope Failures

Existing Issues: The City property at the end of 4th Place constitutes approximately 55 feet of the bluff and is bordered by private property on each side. The overall bluff height is about 28 feet. The private property boundaries are delineated by a retaining wall on the east side and a chainlink fence on the west side. The bluff has a variable slope ranging from 1:1 in the upper/western part of the slope, to 1¾:1 along the eastern edge (against the existing building). The slope within the private property to the west is steeper and exhibits slumping failures in the upper part of the slope. The east side of the bluff area is well vegetated, mostly with iceplant and large bushes.

The bluff area falls within the 2nd Priority category. The calculated factor of safety is near 1.5 on static conditions, which represents a less than fully stable slope. The bluff within public property is visually stable. However, the instability of the bluff on private property may

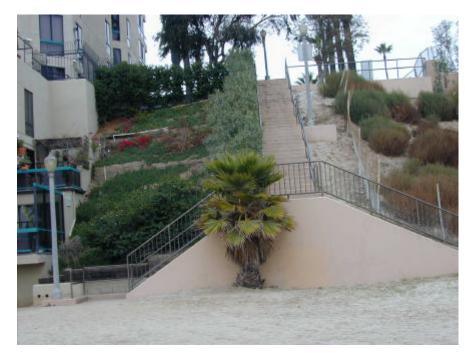
Current condition of 8th Place

- Bluff Instability
- Adjacent Private Property Slope Failures

The bluff area falls within the 2nd Priority category. The bluff within public property is visually stable. However, the private improvements west of the stairway do not appear to be engineered. The calculated factor of safety is near 1.5 on static conditions, which represents a less than fully stable slope.

Proposed Improvements: Replace railroad tie walls with engineered/permitted modular block walls on west side of stairs. Regrade the slope and replant with appropriate coastal plants. Repair the existing irrigation to prevent runoff-caused erosion and improve drainage. Coordinate with private property owners for new development improvements on the east side to ensure a consistent degree of quality when slope stabilization is enlisted.

- Replace Railroad Tie Wall with Modular Block Wall
- Regrade and Revegetate Coordinate with Private Property Owners

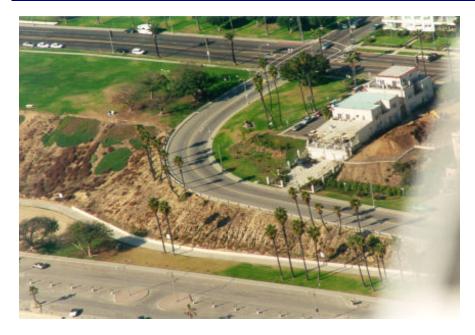
Current condition of the Junipero Ramp slope

Although the slope appears to be grossly stable and well compacted, extensive erosion gullies (up to 2 feet deep) have formed over the slope surface. These gullies coincide with former irrigation head locations, which may have failed, thereby causing severe localized erosion. The guardrail at the top of the slope is loose because the supporting timber posts have rotted. This section of bluff is categorized within the 2nd Priority category.

Mud washing onto the bike path has caused maintenance problems and is a hazard to bicyclists.

Proposed Improvement: A demonstration project has been initiated at this location. The purpose is to demonstrate how Southern Coastal Bluff Scrub and other species which naturally occur in similar areas can be used to revegetate and provide erosion control measures in a deteriorated area. The project consists of the following: regrading the slope, filling in the ruts, and revegetating by hydromulching, hydroseeding and planting appropriate coastal plants; and redesigning the irrigation system with flow control valves to prevent uncontrolled discharge. Once completed, the storm drain system in Ocean Boulevard will be visually monitored to ensure that storm drain overflow does not impact the slope repairs in the event of high rainfall.

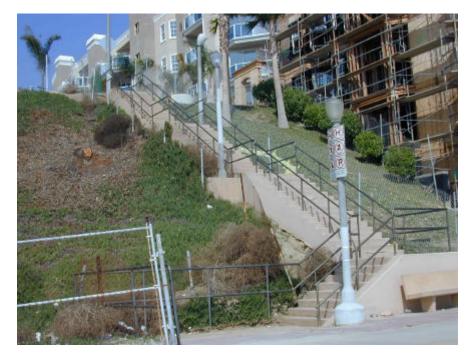
Current condition of 9th Place

- Storm Drain Failure
- Bluff Improvements

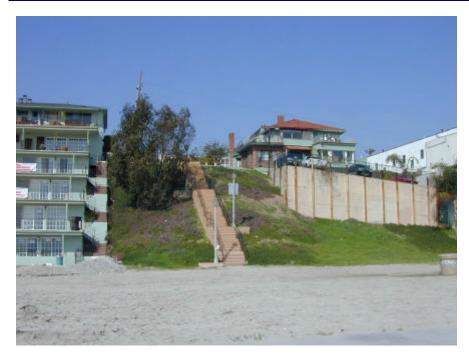
Current condition of 11th Place

- Existing Issues:
- Bluff Improvements
- Unconventional Retaining Wall

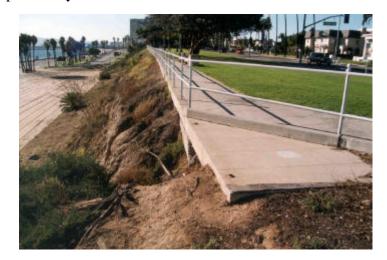
Eroded Bluff and undermined abandoned section of sidewalk west of Lindero Ave.

- Slope Repair
- Revegetation

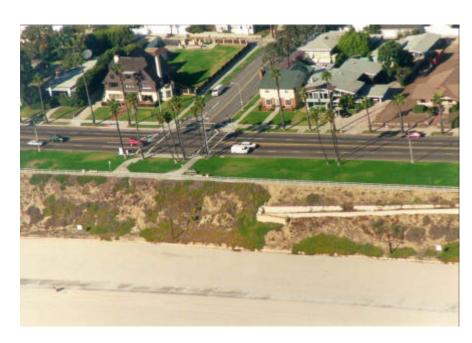
Current condition of bluff at Paloma Ave. showing the western end of historic ramp

Proposed Improvements: Three methods of repairing the slope were developed. To retain the bluff's top edge, the slope can be stabilized with imported fill to reduce its current steepness. This would result in a flatter slope and would extend the toe of the slope seaward. Another alternative is to cut into the existing bluff to achieve a flatter slope, but would result in reducing the existing Bluff Park area (the community expressed concern with reducing the Park area). In order to minimize extending onto the beach and reducing the upper park area, a steep slope would be required. This could be achieved by reconstructing the slope in layers with geotechnical reinforcement. The slope face on a reinforced slope can be very steep, and variable slopes can be engineered to emulate more natural contours.

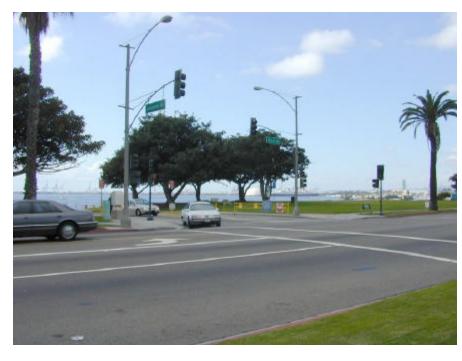
Lack of signage at Junipero Ave. beach ramp.
